NASA Contractor Report 178246

Test Results for Composite Specimens and Elements Containing Joints and Cutouts

P. T. Sumida, R. C. Madan, and A. V. Hawley

Douglas Aircraft Company
McDonnell Douglas Corporation
Long Beach, CA 90846

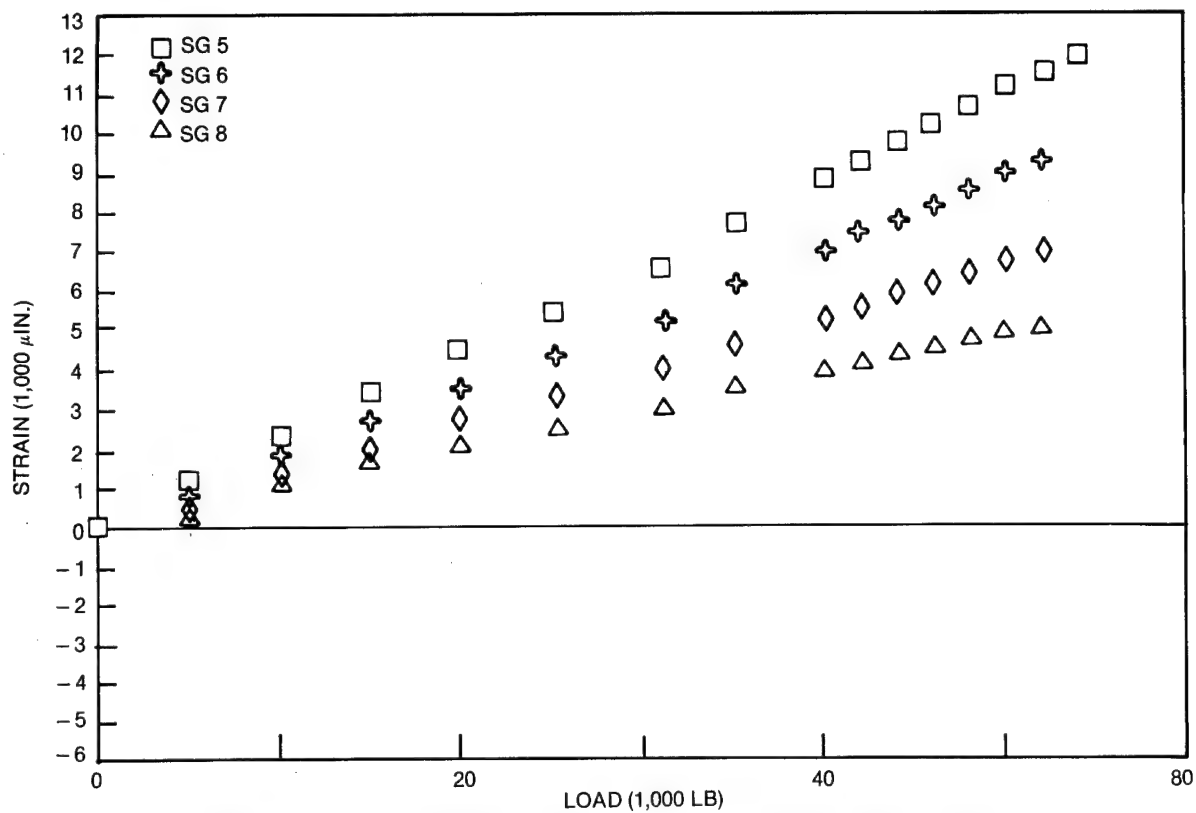
Figure 5-23. Typical Strain Gage Data for Tension Cutout Panel (-501)

The baseline panel (-501) was the only one to buckle in opposite directions at the top and the bottom of the cutout. This is illustrated in Figure 5-22 by the asymmetry of the photoelastic fringe pattern at 31 kips. Although difficult to discern, the top of the cutout buckled toward the camera, producing tensile strains on the surface being viewed, which subtract from the membrane compressive strains to produce a black, or zero-principal-strain, region. Likewise, the buckle at the bottom of the cutout is away from the camera, producing bending strains which add to the compressive membrane strains. Typical plots of strain gage and photoelastic data are shown in Figures 5-23 and 5-24.

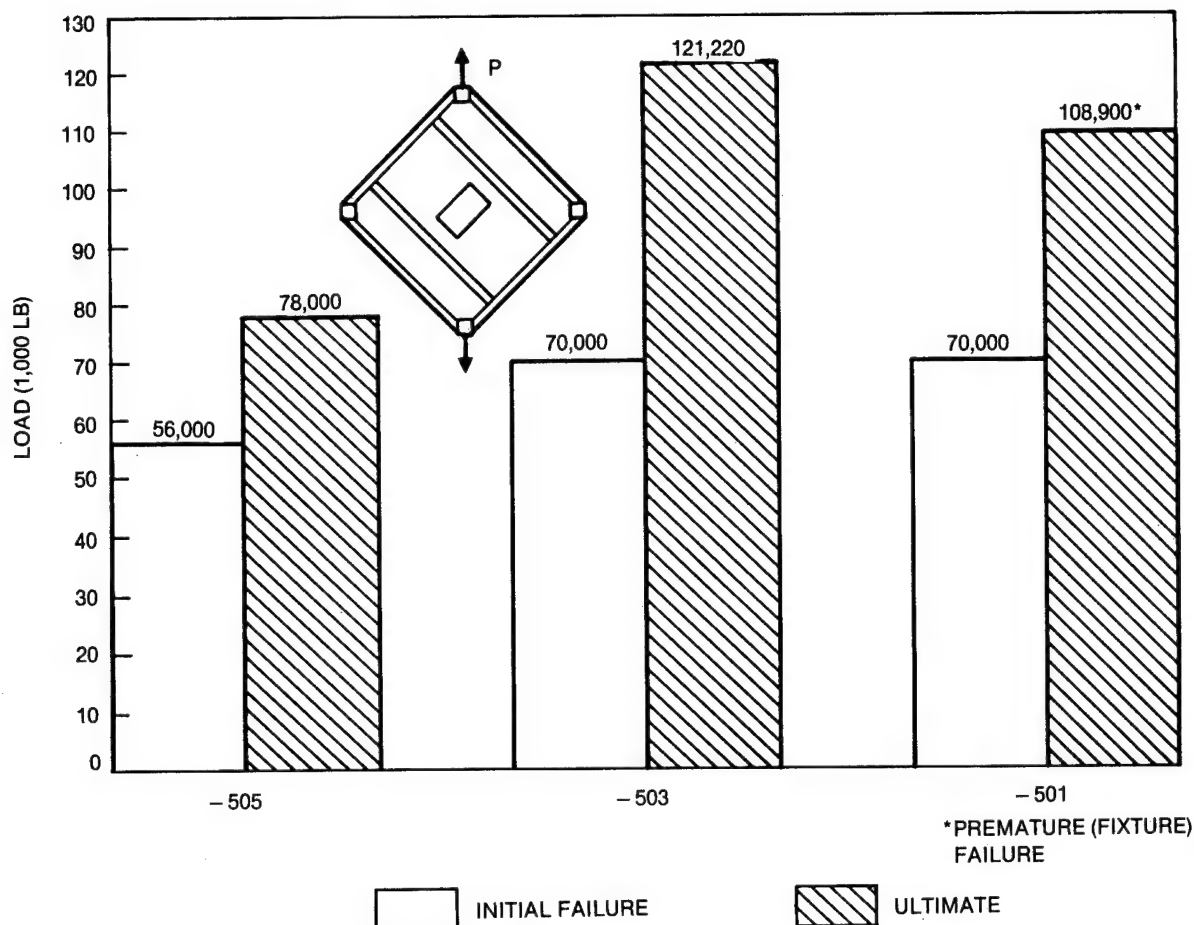
Figure 5-25. Failure Loads for Group B Shear Cutout Panels

A summary of the failure loads for the shear panel tests is given in Figure 5-25. All three panels failed initially at the top and bottom corners of the cutout. These localized failures did not result in the collapse of the panels, however. As indicated, the ultimate failure of the -505 panel was precipitated by a partial failure of the picture frame load introduction fixture. Strain gage data indicated that the panel was close to failure before this occurred.

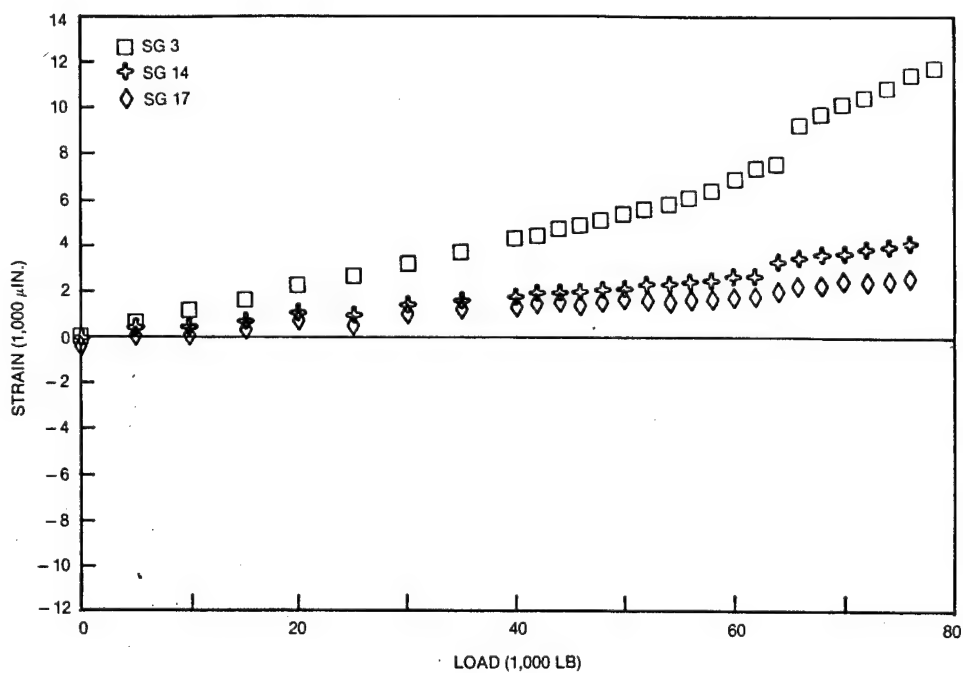
Figure 5-27. Strain Gage Data at Top Corner of Shear Panel Cutout (-501)

A sketch of the failed baseline panel (-501) is included as Figure 5-26. Strain gage data (Figure 5-27) taken at the top corner indicate a moderate change in slope at about 30 kips and a marked nonlinear behavior beginning around 50 kips. While holding the load at 56 kips, a loud noise was heard, and while holding at 58 kips, a drastic drop in measured strain at the top corner ($-9,830$ to $-2,632 \mu\text{in./in.}$) was observed. Inspection of the test article revealed delaminations at the cutout on both compression diagonals (top and bottom corners). As the load was increased, these delaminations were observed to progress toward the intersections of the stiffeners. Panel failure occurred while holding at 78 kips. Ultimate failure appears to have resulted from the stiffeners having disbonded from the panel, thus effectively eliminating the last remaining load path for the diagonal compression load.

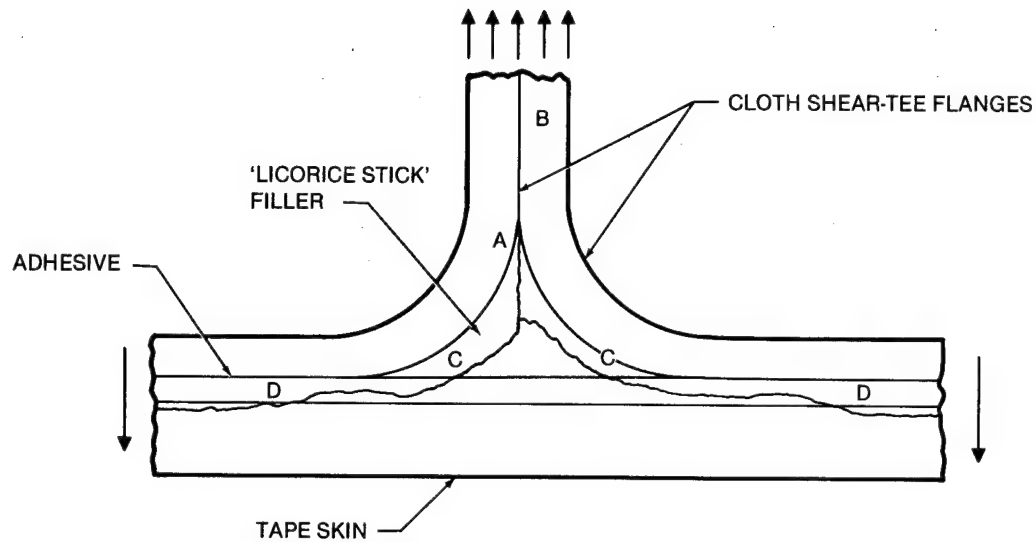
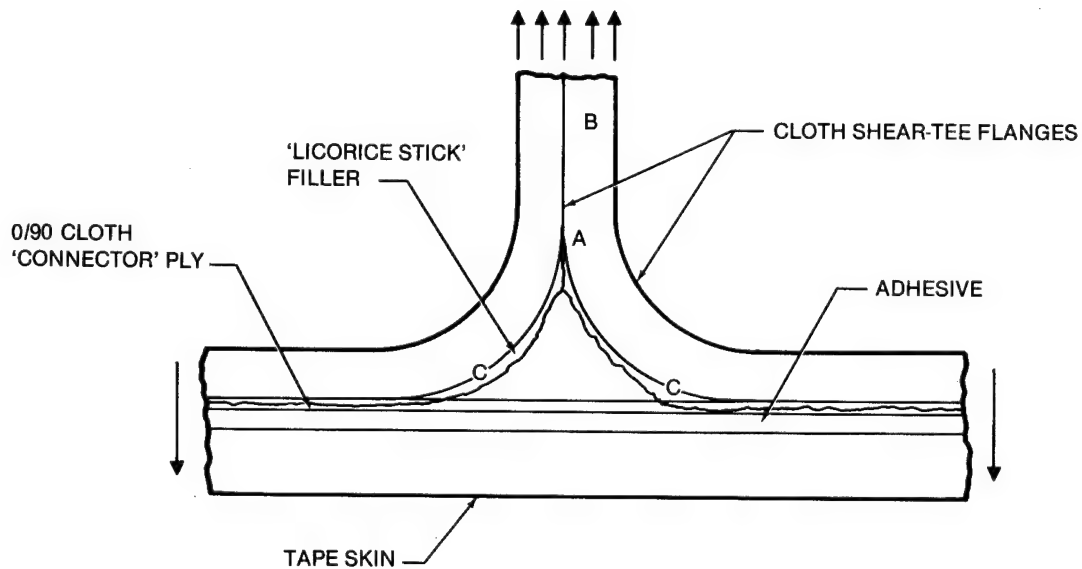
Figure 5-30. Apparent Failure Sequence for Shear-Tee Pull-Off Specimens

Six configurations of the shear-tee/skin intersection were examined. The results of these tests are summarized in Table 5-3. The -503, -509, and -511 configurations all yielded similar results, indicating that neither the alternate adhesive nor the presence of the imbedded hoop plies in the skin had a significant effect on the pull-off strength. The gradual tapering of the shear-tee flange (-505) did, however, result in a noticeable increase in the pull-off load (up to about 425 lb/in.). The worst performers were the -501 and -507 configurations (at about 250 lb/in.), indicating that either adding a ply to connect the tee flanges or thinning/softening the tee as a whole can reduce the pull-off strength dramatically. Figure 5-30 depicts what is thought to be the failure sequence for the shear-tee pull-off specimens. During testing, a loud sound was heard at anywhere from 10 percent to 40 percent of the ultimate failure load (depending on the configuration). As the load continued to increase, a crack was sometimes visible in the region from A to C. These cracks are thought to have originated in the vicinity of A and tended to spread both upward toward B and through the filler material toward either of the C points. Eventually, the cracks would reach a critical length and the specimens would fail suddenly. Examination of the failed specimens revealed adhesive on both the (now separated) tee and skin elements in areas to either side of center. This indicates a cohesive bondline failure in this area (corresponding to the area between points C and D. To either side of this region, there is very little adhesive visible; instead, 0-degree strands are observed on both elements, indicating an interlaminar failure in the first ply of the skin. The -501 specimens, however, showed no sign of any adhesive or 0-degree tape on the failure surface. Instead, there was the very distinct pattern of the 0/90-degree cloth, indicating an interlaminar failure in the tee assembly.

Relating the apparent failure sequence back to the specimens provides some insight into their relative performance. The -503, -509, and -511 specimens all had identical tee elements. Apparently, neither the alternate adhesive, nor the increased stiffness of the skin under the tee, had any significant effect on the peel stress at point C once the crack had propagated to that point. The higher strength of the -505 configuration was likely due to a reduction in this peel stress, effected by the tapered flanges flexing with the

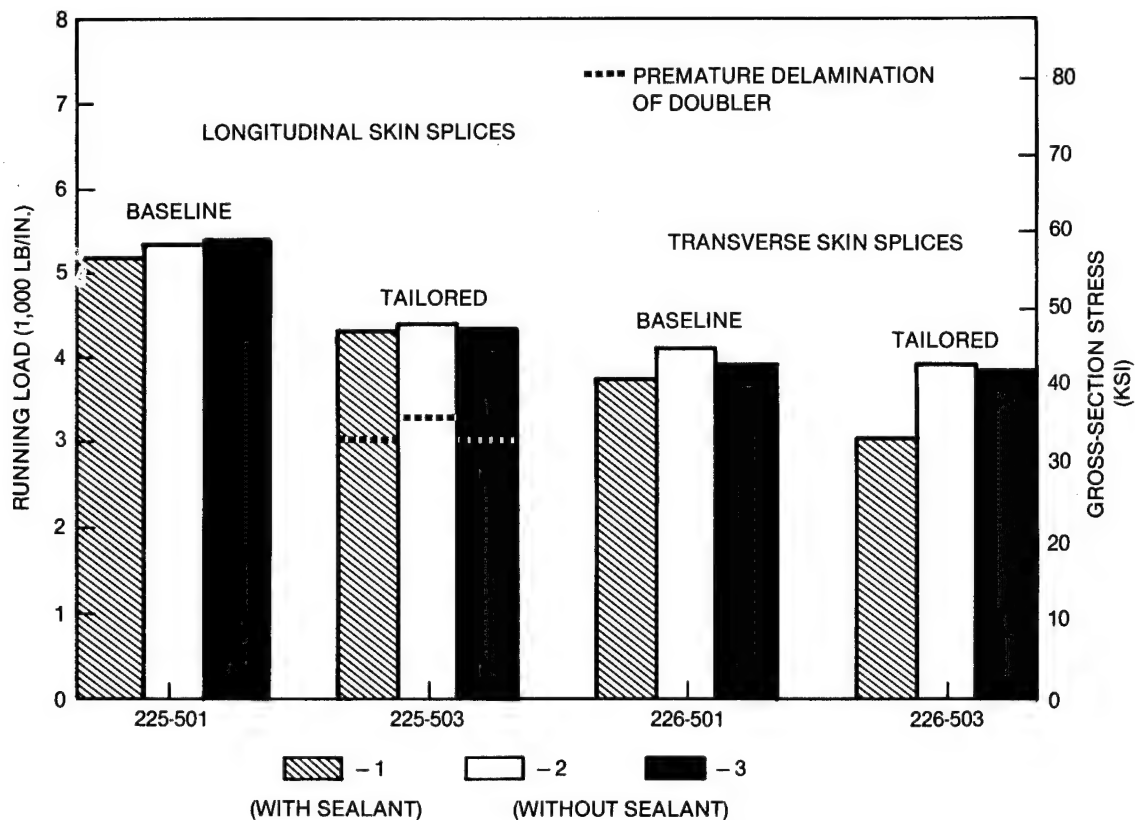
Figure 5-31. Failure Loads for Group C Skin Splice Specimens

The results of the skin splice tests are summarized in Figure 5-31. All of these specimens were fabricated from the basic skin laminate (0.0684 inch nominal thickness) to which four plies of 45 were added at the splice region to yield the reinforced skin laminate (0.0912 inch nominal thickness). Gross-section stresses are based on the built-up thickness. Gross-section strains can be obtained by dividing by measured modulus of elasticity for lay-up No. 2 (7.96 Msi). The first replicate of each of the skin splice configurations was tested with faying surface sealant while the second and third were tested without. The presence of the sealant had little effect on the strength of the longitudinal skin splices. The strengths of the transverse splices were more noticeably affected (reduced) by the presence of the sealant. This reduction is generally attributed to the increased eccentricity of these single-shear joints due to the added thickness of the sealant.

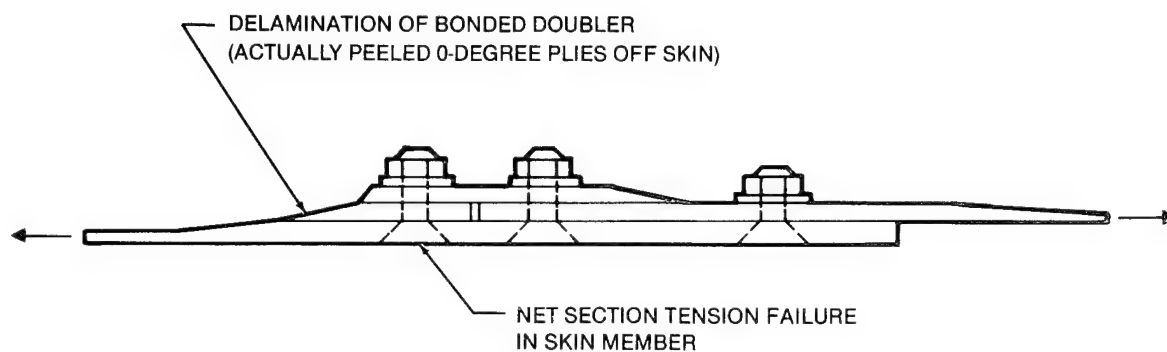
Figure 5-32. Failure Mode of Tailored Longitudinal Splice Specimens

The tailored longitudinal splice specimens experienced premature doubler delaminations prior to failure. Figure 5-32 illustrates the location of the initial delamination as well as that of the ultimate (net-section tension) failure. The taper angle of the small doubler bonded to the left-hand skin was apparently too steep to allow it to conform adequately to the deformed curvature of the skin. The resultant peel force at the end of the doubler thus precipitated the premature delamination. (Note that this was not a bondline failure, but rather was an interlaminar failure in the first ply of the skin.) With the doubler separated from the skin, the ultimate failure occurred in the countersunk skin at the outermost fastener.

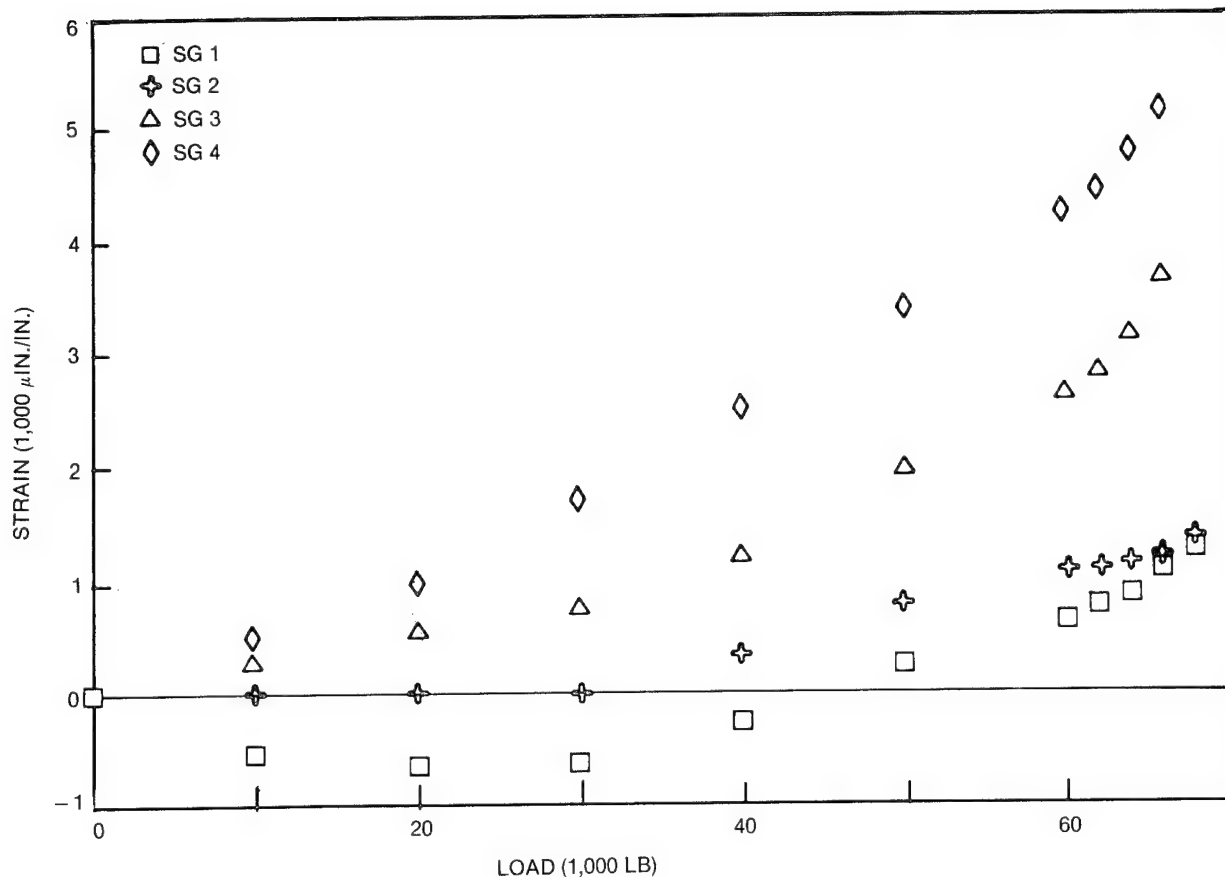
Figure 5-36. Transverse Skin/Longeron Splice Typical Strain Gage Data (Tension)

Strain gage data taken in the vicinity of the splice was noticeably nonlinear. This geometric nonlinear behavior (a result of the eccentricity of the single-shear skin splice) is especially notable in the data from strain gage No. 1 (Figure 5-36). This gage, located in the center of the skin-splice plate, initially read negative even though the applied load was tension. The strain readings leveled off quickly, however, and eventually became positive at about 45 kips. Considerable local bending of the skin and skin-splice members was also visually confirmed during the test. Although not visually detectable, the strain gage data also indicated a degree of eccentricity in the longeron splice, with the strains generally higher in the L-member than in the Z.

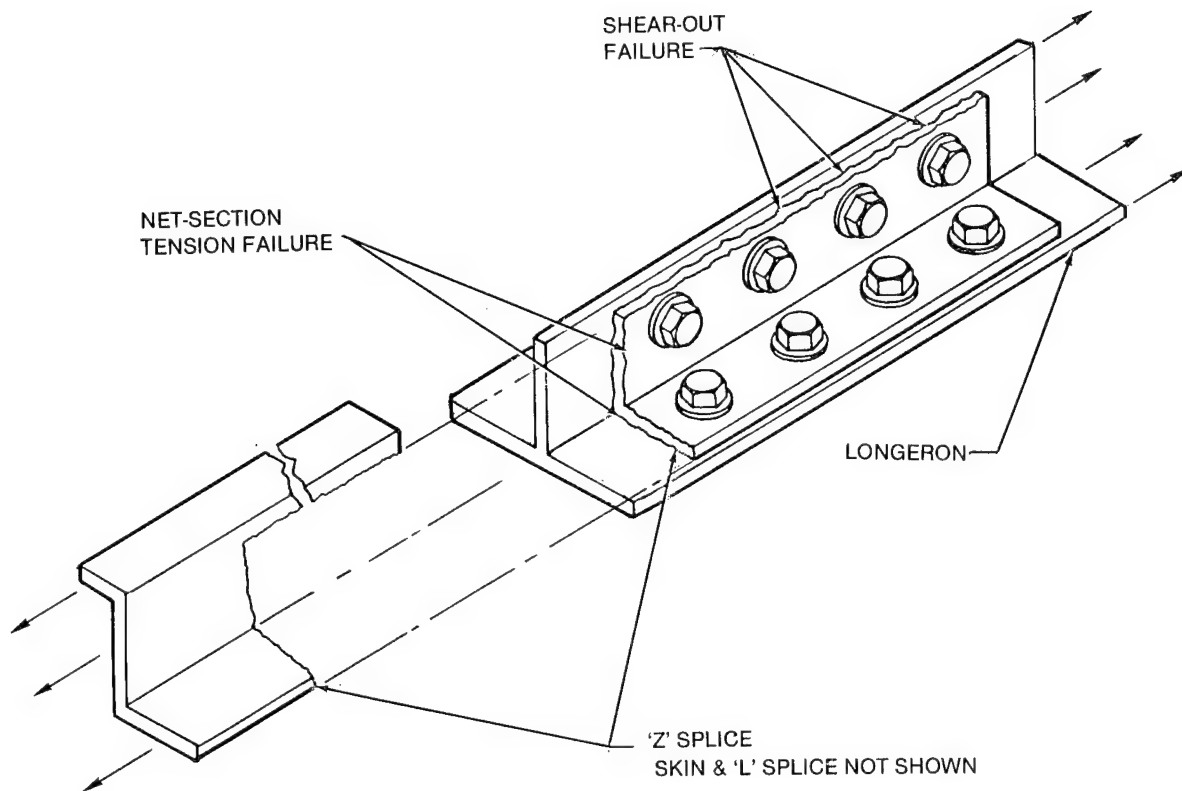
Figure 5-37. Failure Mode of Longeron Splices (Tension Specimen)

The apparent failure mode of the skin splice was a combination of fastener failures and fastener pull-through. It is observed that more of the failures in the outer row were by pull-through, while more of those in the inner row were failures of the fasteners themselves. Failure mode of the stiffener splice was a combination of net-section tension and shear-out. This failure mode, typical of both the L and Z splices, is illustrated in Figure 5-37. The shear-out failure, just above the line of 1/4-inch fasteners which attached the splice plates to the stiffener web, was typical of the failures experienced with the highly orthotropic reinforced longeron laminate (lay-up No. 3) in the Group A testing. The stiffener webs, as well as the Z and L splices were fabricated from this (54,23,23) laminate. The lower half of each splice, however, failed in net-section tension. This failure, through the innermost fastener attaching the splice flange to the longeron flange, was unique in that it was the only loaded-hole test for this laminate that failed in any mode other than shear-out. (See the discussion of the DLT test results from Group A.)

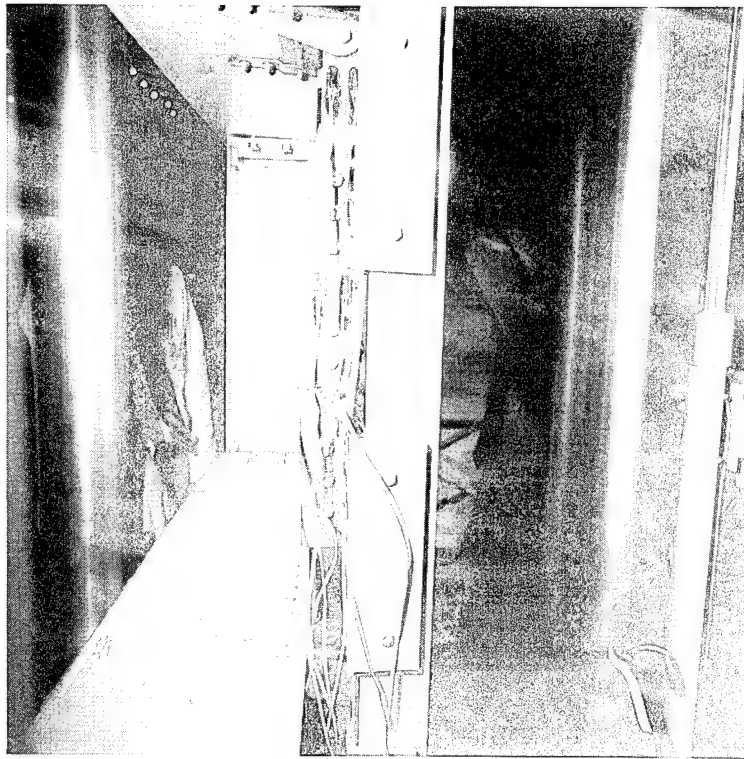
Figure 5-40. Failure of Longeron/Skin Splice Panel (Compression Specimen)

Figures 5-39 through 5-41 show several views of the specimen after failure. The skin failure (best seen in Figure 5-39) did not occur through the skin splice. The damage did, however, go through several of the fasteners which attached the skin/longeron flange combination to the Z and L stiffener flanges. At the panel edges (Figure 5-40), the skin failure was just below the splice plate, and just above the edge support. Failure of the Z and L splice plates (Figure 5-41) likewise did not occur through the longeron splice. The splice plates failed through two fastener holes; however, the load transfer at these fasteners should have been minimal. (These attachments were simply designed to stabilize the Z and L splice members where they bridge the stiffener load across the skin splice.)

Again, the exact failure sequence is not clear. A likely candidate for the initial failure is the skin failure at the edge of the panel due to the unrealistically sharp curvature induced at that point by the edge support system. Pull-through of the fastener heads after delamination of the skin and stiffener could also have contributed to the skin failure. After skin failure, all the load would have to be carried by the Z and L splice members. The attachments mentioned above (designed to stabilize the splice members) would likely have picked up significant loads. These factors, coupled with the added eccentricity of the partially failed joint, would cause failure of the stiffener splice elements.

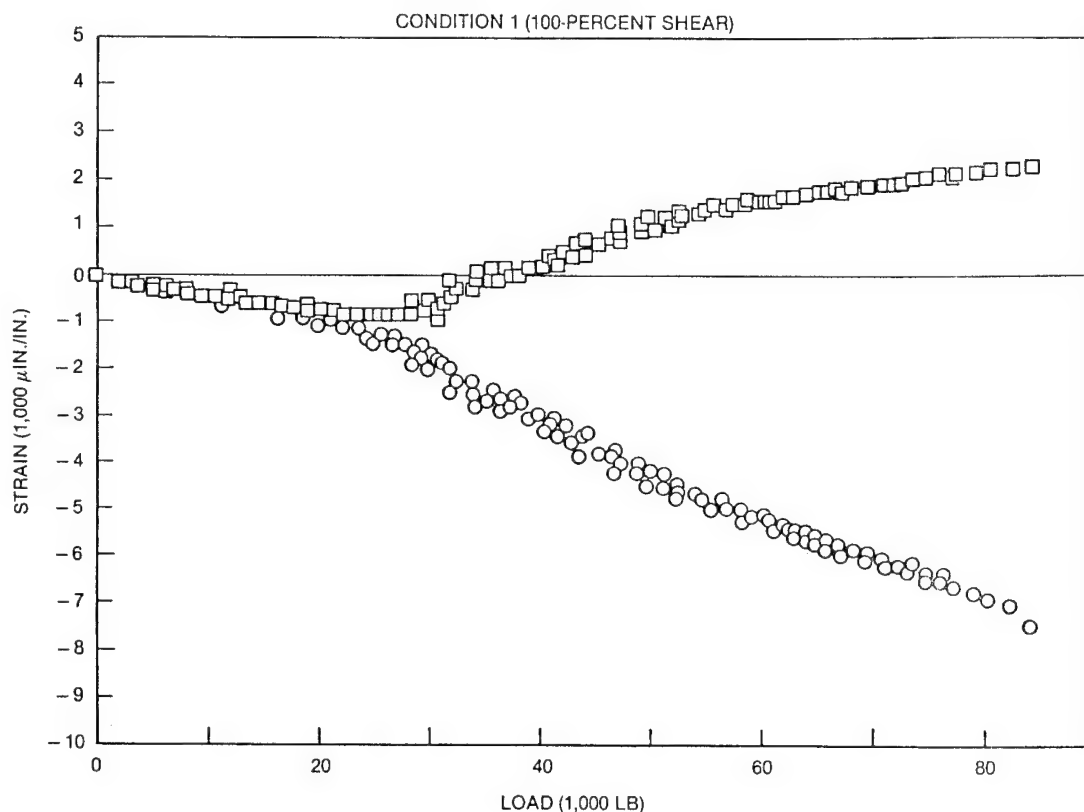
Figure 5-45. Postbuckling Response of Transverse Skin Splice Panel (Shear)

Strain gage data for this specimen (see Figure 5-36) provided information concerning skin buckling and the behavior of the transverse splice. The continuously read data for the shear-only conditions (discussed above) are presented in Figure 5-45. The data and the failure load of 84.1 kips suggest a post-buckling ratio for this panel of between 2.5 and 3.0 (depending on the choice for the initial buckling load). Strain gage data from the small skin bay just above the splice (strain gages No. 5 and 6) indicate a small amount of curvature, which suggests a very shallow buckle present here also. (Skin thickness in this bay was nominally 0.0912 in.). Strain gages at the joint indicated behavior similar to that of the two-stiffener transverse splice panel loaded in compression (i.e., nearly equal strains in the Z and L splice members, and tensile strains on the inside surface of the skin splice plate). The strains at the joint were generally quite low due primarily to the fact that the highest compression load applied was 75 kips, corresponding to a running load of about 1,800 lb/in. (this to be contrasted with the failure load of the two-stiffener panel of 3,336 lb/in.).

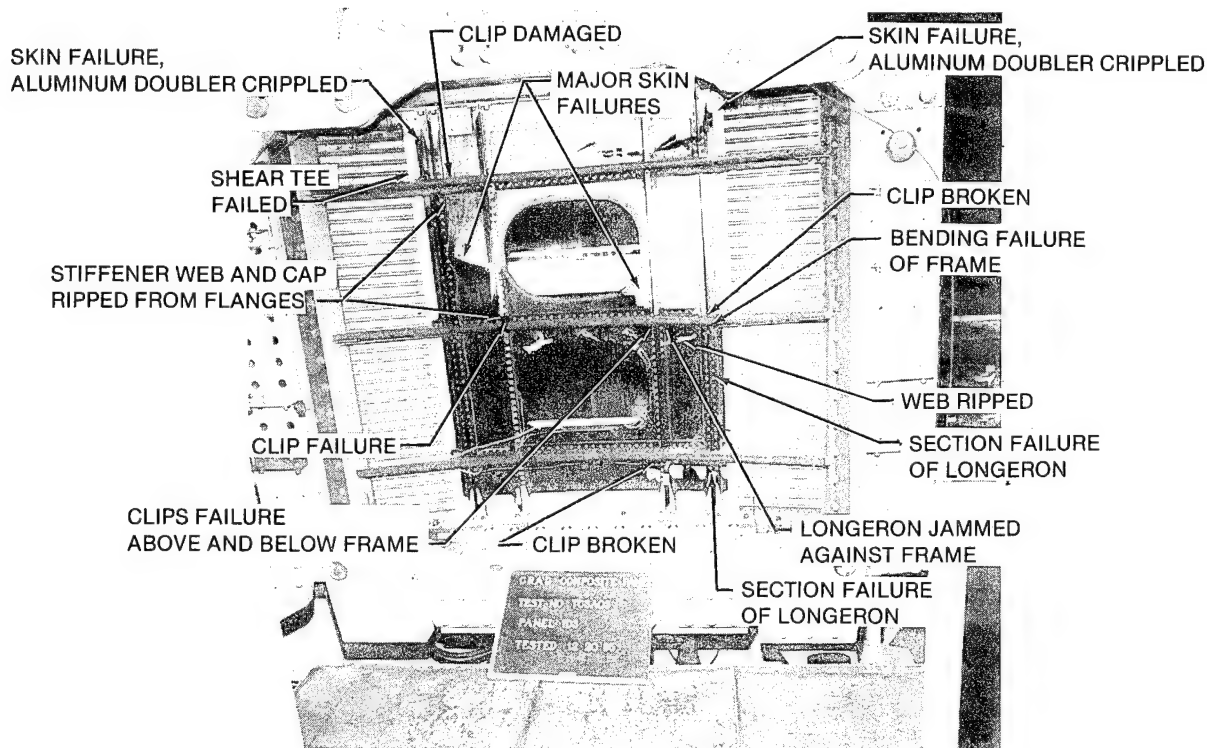
Figure 5-46. Group D Window Belt Panel Showing Failure Locations

Figure 5-46 shows an overall view of the panel and points out a number of failures noted during a visual inspection. The overall failure appears to be of a general stability nature, with the middle of the panel collapsing inward. Figure 5-47 is a closeup of the upper left portion of the panel. It is apparent from the videotapes of the panel failure that this area was the first to collapse. This was also the area (referred to above) where the delamination and/or buckling was observed. The skin failure at the cutout appears to be an interlaminar tension failure induced from high compression loads. Note also how the web of the stiffener in the foreground was ripped away from the flanges, which remain attached to the skin.

Strain gages at the upper right-hand corner of the lower cutout in Figure 5-46 also displayed a nonlinear characteristic with a moderate amount of bending. These strains were tensile for the shear-dominated conditions and compressive for the compression-dominated conditions. Although a skin failure is indicated at these gages in Figure 5-50 (the upper left corner of the lower cutout), the measured strains were quite low just prior to the collapse of the panel. This adds credence to the observation made from the videotapes that this side of the panel was not involved in the initial failure.

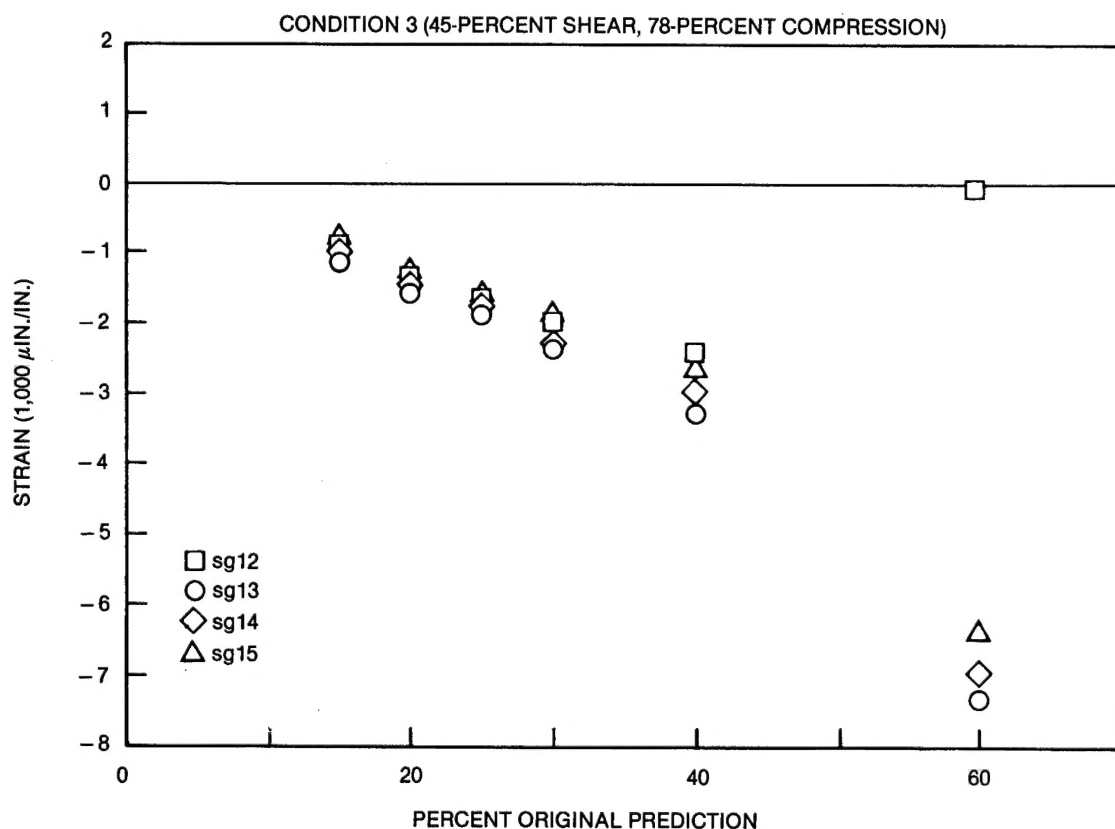
Figure 5-51. Selected Strain Gage Readings for Window Belt Panel

The strains recorded by the gages above and below the cutout remained relatively linear, and were (expectedly) higher for the shear dominated load cases. Those recorded by the gages along the left and right edges were likewise highest for the compression-dominated conditions. There was a noticeable nonlinearity in these data, indicative of either a redistribution of load in the panel, or bending along the cutout. The data from strain gages No. 12 through 15 are the most interesting. The gages located at the lower right-hand corner of the lower cutout (see Figure 5-46) showed the presence of high-compression loads for the shear-dominated conditions. Significant bending was indicated at this location by the difference in the readings from the back-to-back strain gages. These readings were also the most obviously nonlinear. The most dramatic example of this behavior is evidenced in the plot for these gages for Condition 3 (included here as Figure 5-51). It would appear from the severity of the bending indicated at this condition for the 60-percent load series, that a failure at or close to this area had already occurred. However, there was no damage to the skin in this region.
